# *Final Report*

## **Deflecting the Wave: Using Coastal Vegetation to Mitigate Tsunami and Storm Surge**

Tropical Landscape and Human Interaction Lab  
Department of Tropical Plant and Soil Sciences  
College of Tropical Agriculture and Human Resources  
University of Hawai‘i at Mānoa

**June 2015**

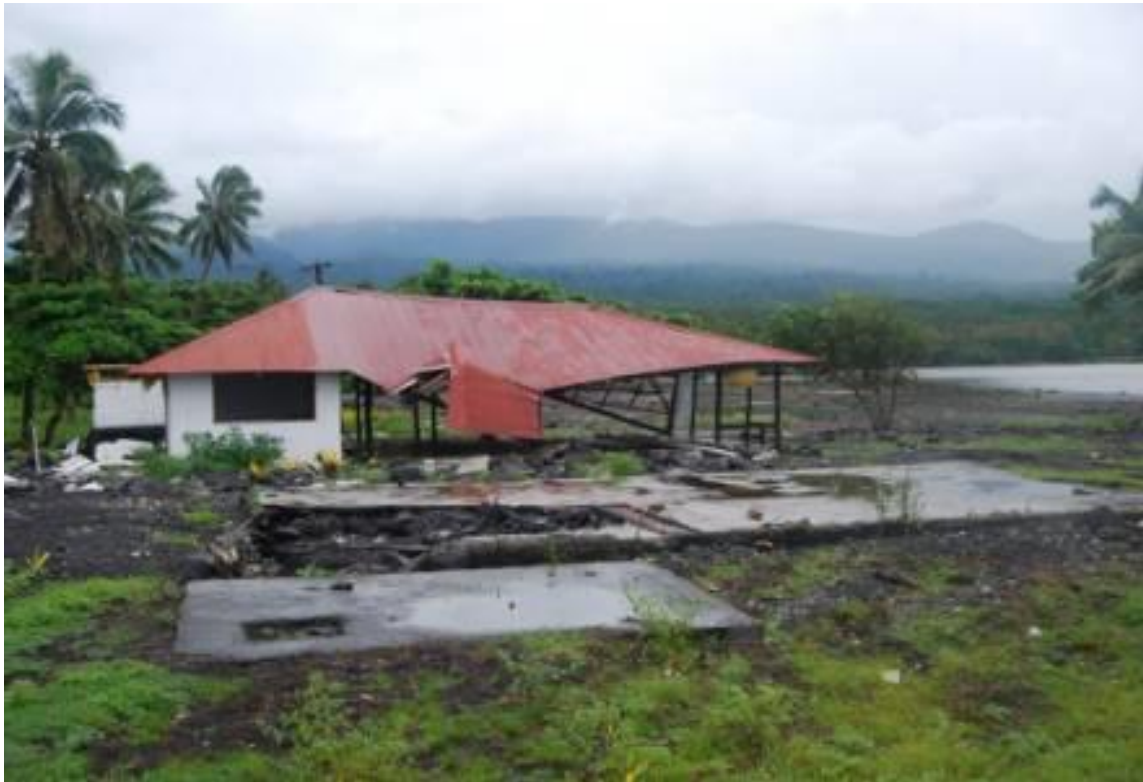
Figure 7: Extensive Damage to a resorts structures at the Peninsula West of Saleilua

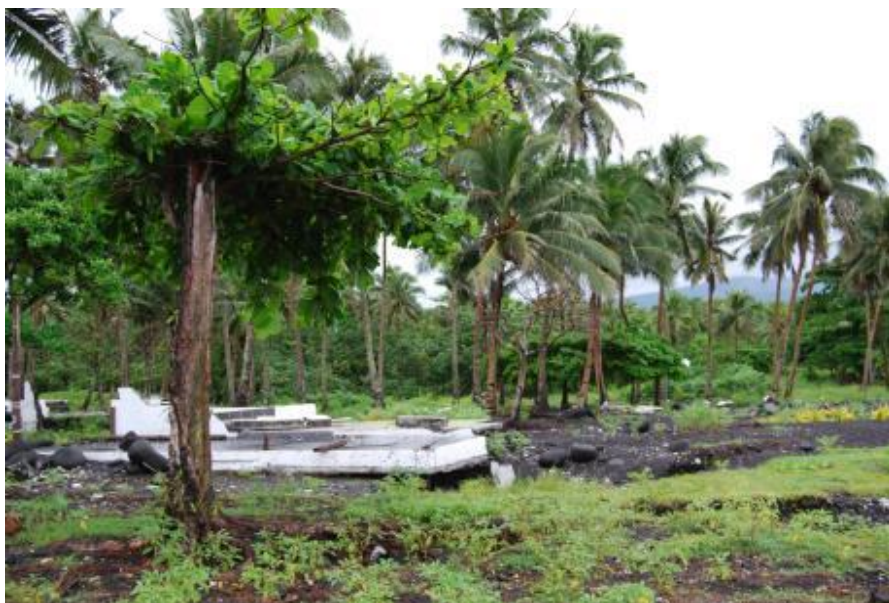
Figure 8: Trees remain standing at the Iliili resort although buildings in this area were completely destroyed. This area was partially cleared and represents a low density cleared forest.

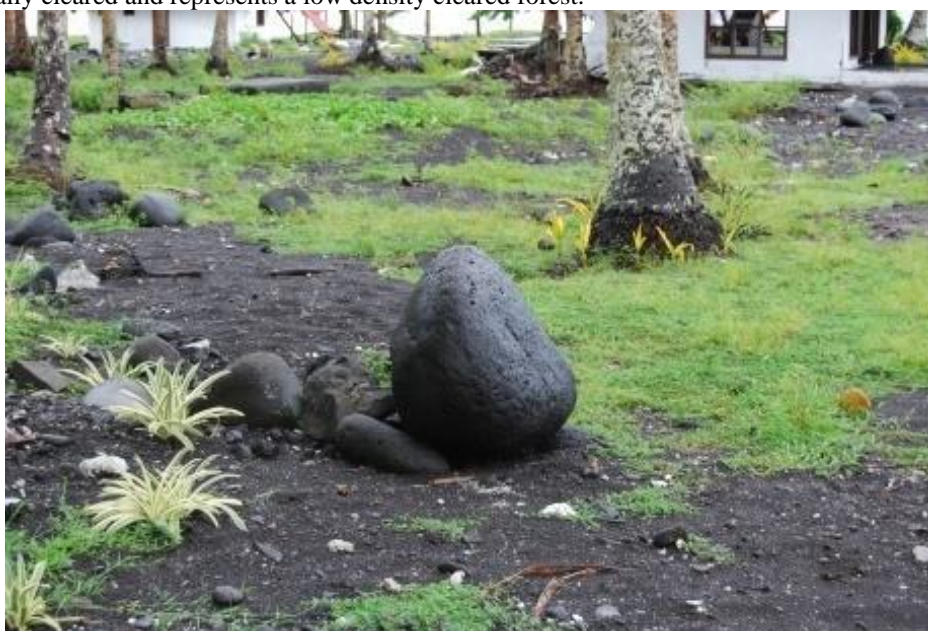
Figure 9: Large boulders from a coastal seawall, including the one shown here, were carried over 100 meters inland by the wave.

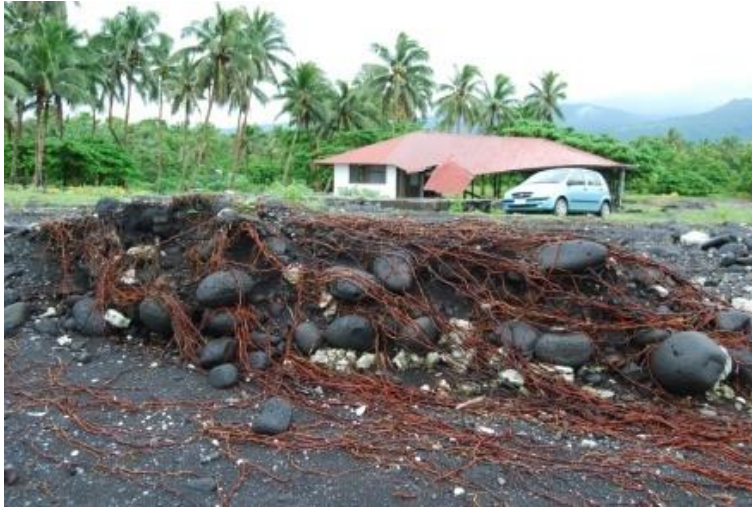
Figure 11. Coconut tree roots planted near to a sea wall likely helped to prevent these rocks from being moved inland

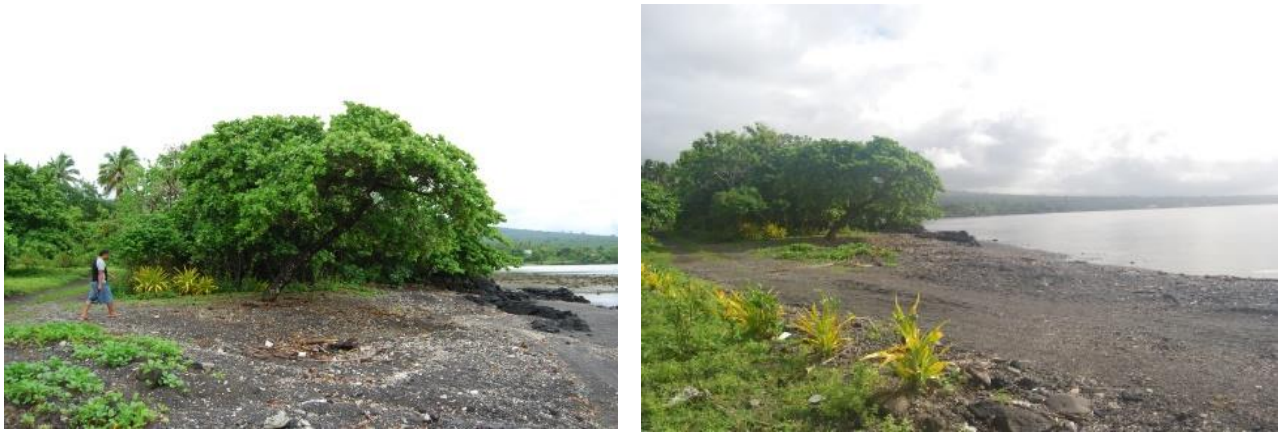
Figure 12. This image shows the south edge of the densely forested buffer between the road to the Iliili beach resort and the coast. The vegetation is situated on (or may have contributed to the slight increase in elevation visible along the shore front.

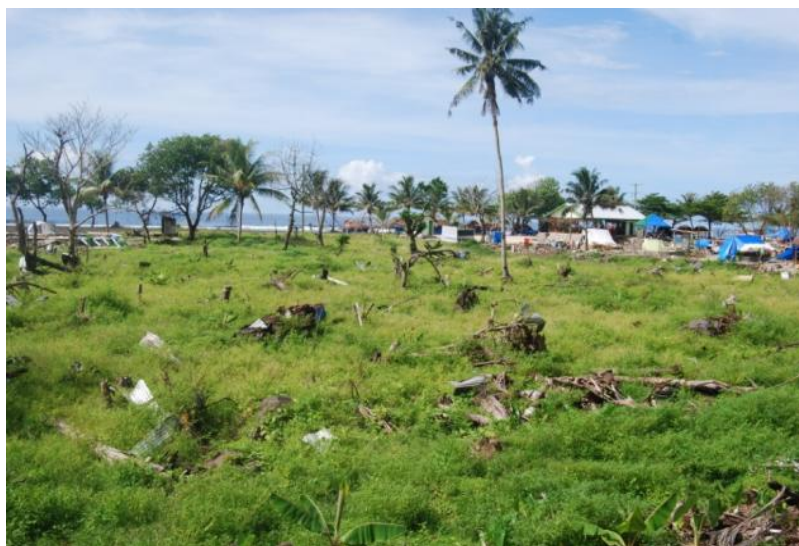
Figure 16. Inundated coastal plain showing debris field at Saleapaga.

The wave inundated the entire coastal plain and travelled several meters up the wall of the mountain. Inundation points were obtained however elevation contours were not obtained for this site and their analysis would not be appropriate given the very steep slope in this area and the restricted resolution of the teams GPS unit. The UNESCO study found a maximum run-up elevation of between 5 and 6.5 meters.

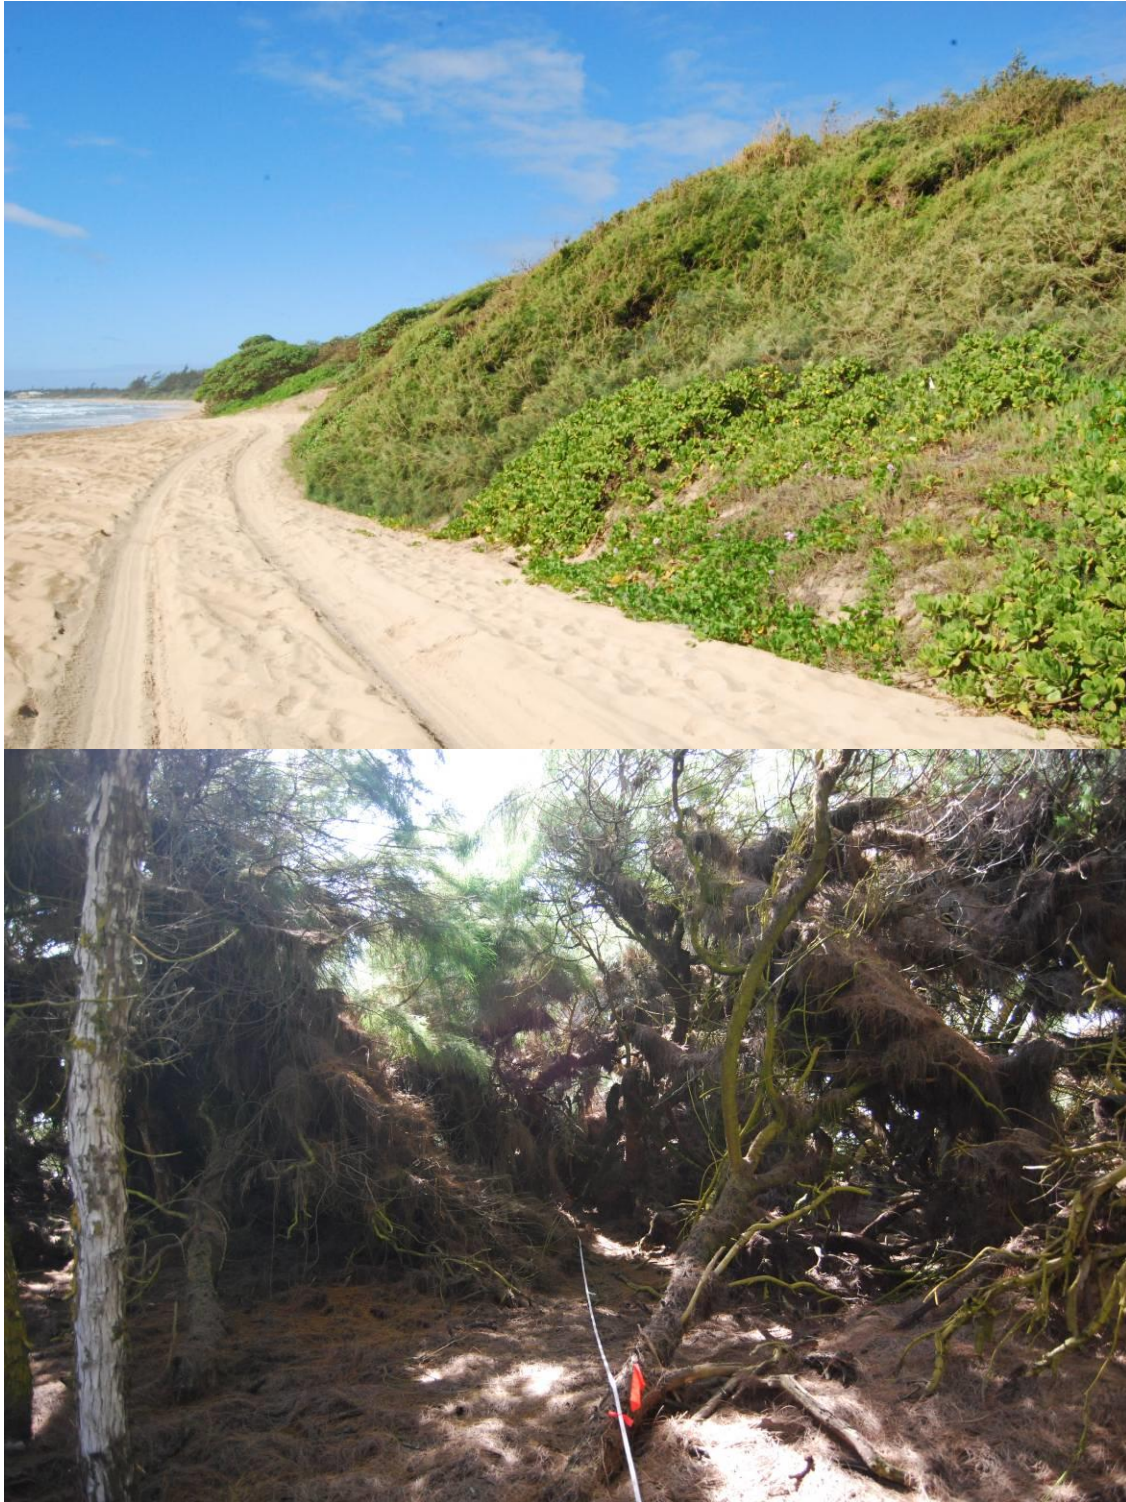
Figure 30. *Casuarina* will take on a windswept form and will contribute to dune formation in high exposure areas when left unmanaged. Images above from the Windward coast of Kauai show the outside (top) and interior view (bottom) of a windswept tangle of *Casuarina* under which a sand dune approximately 1.5 meters high has formed.

areas and steep cliffs. *Casuarina* forms nearly monotypic stands with limited understory development. This is potentially due to allelopathy since the branch and leaf structure of a *Casuarina* canopy usually allows in a substantial amount of light. This species is also potentially self allelopathic. Seedlings of *C. equisetifolia* are rare under its own canopy but tend to be prolific on nearby areas such as on exposed otherwise unvegetated sandbars on Kauai. Trees however produce root suckers which in some cases may grow to form an independent tree. *Casuarina* can appear shrub-like and can form dunes particularly if left unmanaged and if its canopy is allowed to grow to the ground along the top of the beach.

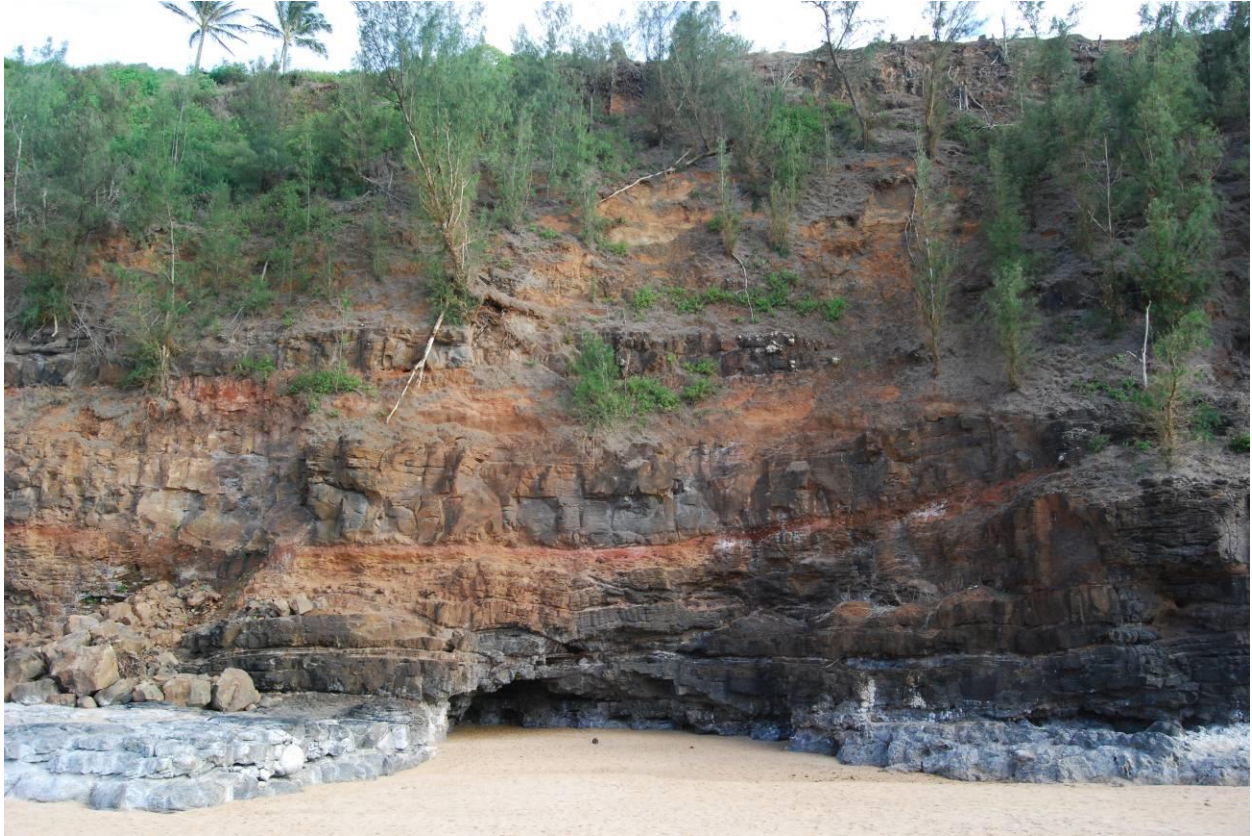
Figure 31. *Casuarina* established well on areas with a high slope including on sheer cliff faces.

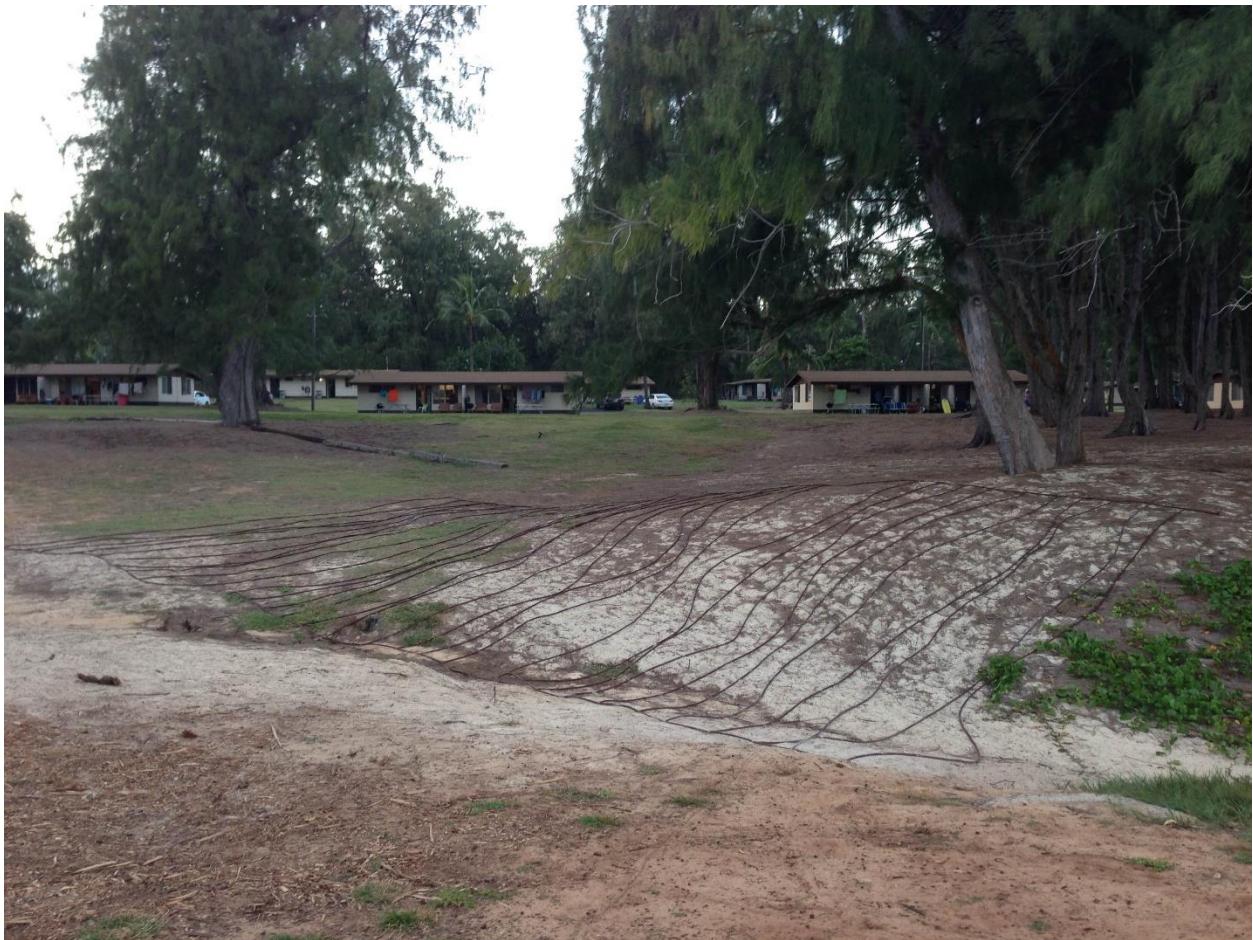
Figure 56. Drip-lines removed from an established plot, ready for a new planting.

Since the use of shrubbers and sprinklers was not the best option, as described before, the second option to explore is dripline. Dripline offers the benefit of uniform flow rate, and modular design, which in turn allowed to easily remove the irrigation system after the plants were established (Figure 56). In this experiment, the drip lines were removed ten months after planting and re-used in new plots, avoiding debris on site, and reducing the cost for new restoration sites. The system (Figure 57) was designed using the TECHLINE design manual, and a cost estimated is presented on table 15.

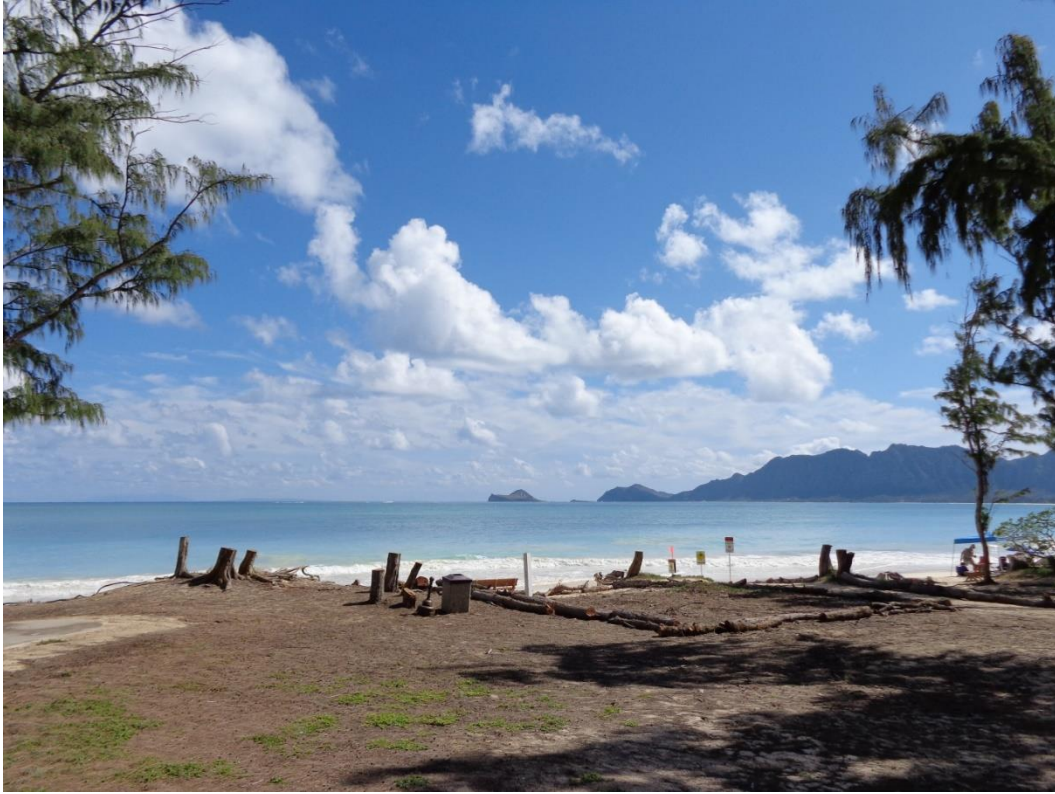
Figure 60. Plot 1 after cutting down the ironwood tree, partially ready for irrigation and planting.

Once cleared, the plot limits (32 feet long by 52 feet deep) were delineated with tree logs cut on site). After the plots were cleared, the logs from the cut ironwood trees were used to draw the boundary of the plots, measuring 30 feet long and 50 feet deep (figures 60 and 61). All branches and accumulated ironwood leaves were raked out of the plots. Weeds were removed as well.

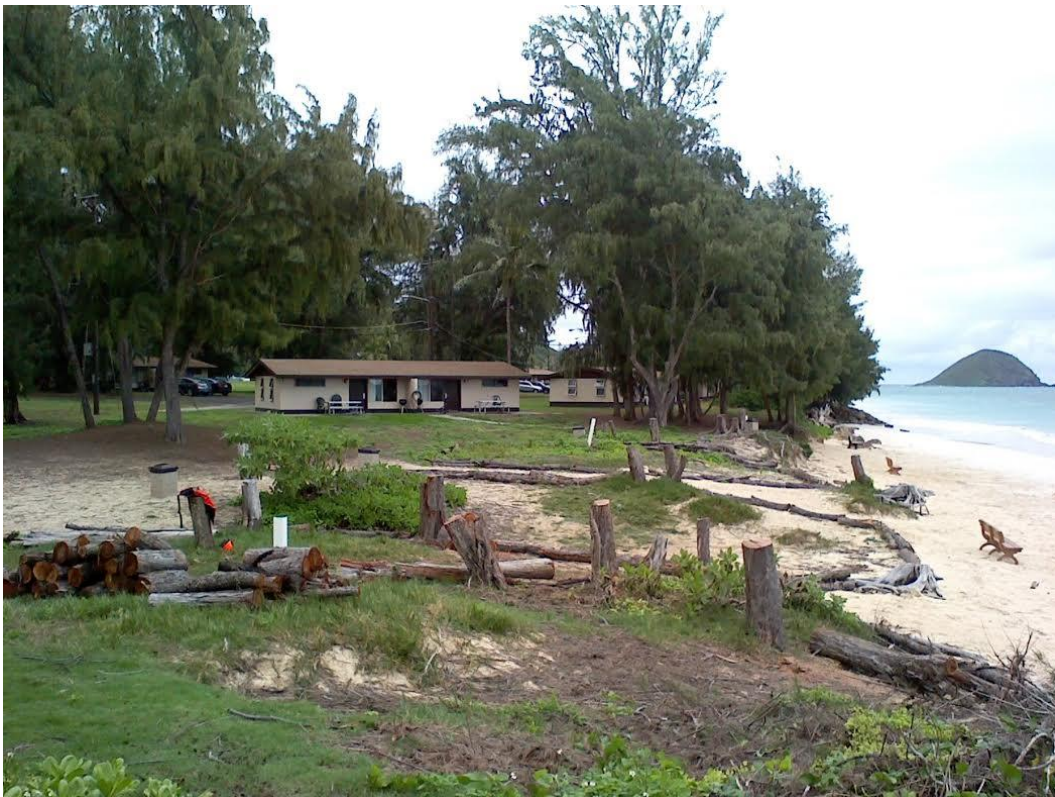
Figure 61. Plots ready for planting.

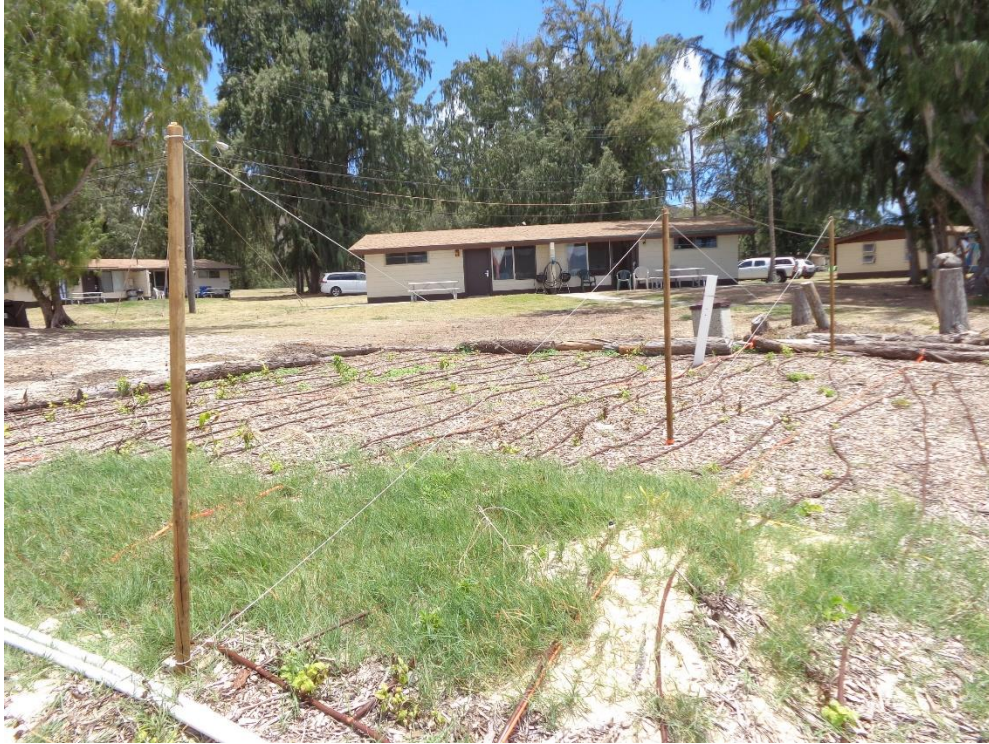
Figure 63. Steel cables used for wind screen support.

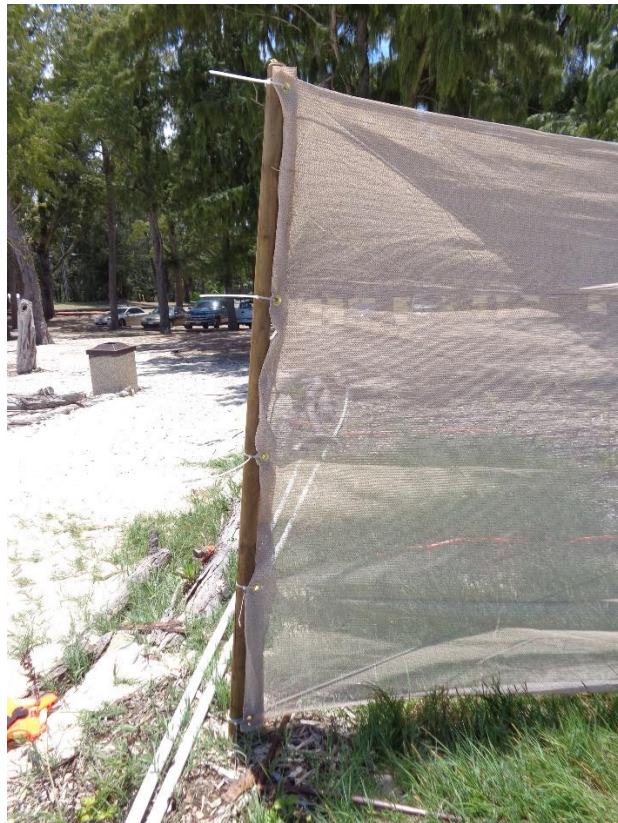
Figure 66. Windscreen attachment detail.

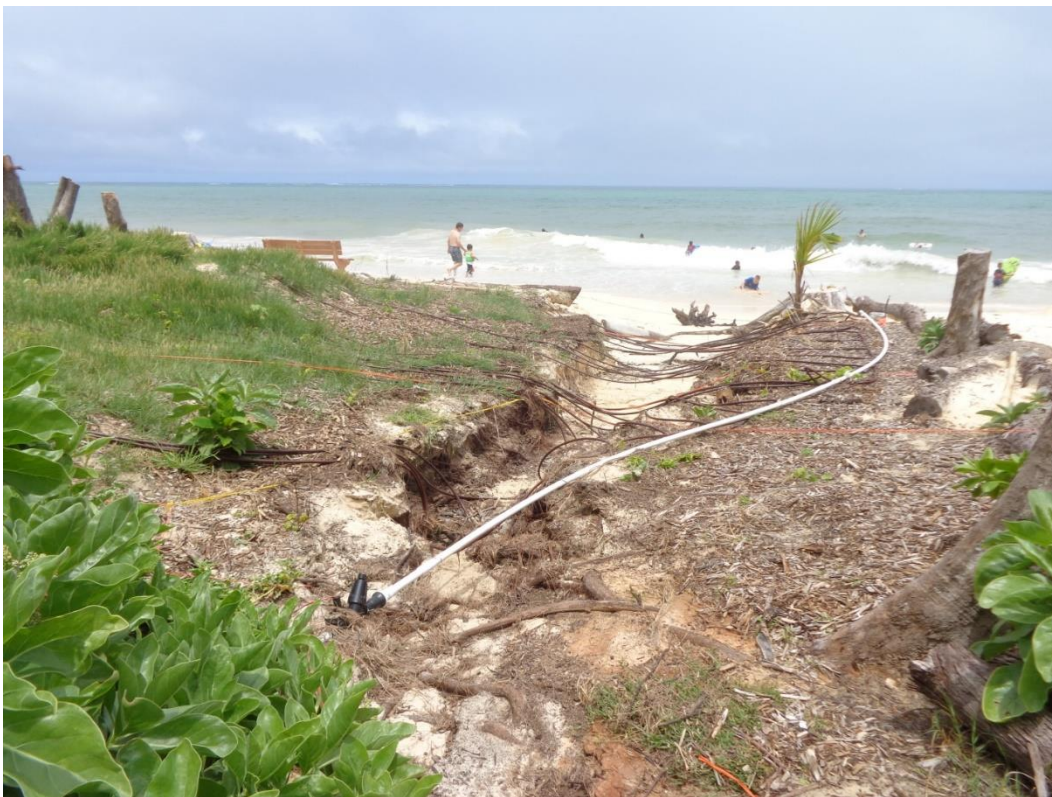
Figure 67. Plot after storm, 07/21/2014

The plots at Site 1 were heavily damaged by a storm that occurred about one month after planting. The plot without screen was washed off by storm water that run thought the experiment, and the drip lines were buried more than 2 feet deep when the sand returned naturally through tide and wave action (Figures 67-70). The irrigation lines were dug out of the sand, re-organized, and the vegetation (mostly *Ipomea pes-caprae* and *Sporobolus sp.*) completely covered the plot, which was partially uncovered, with exposed sand before the experiment (Figures 71-73).

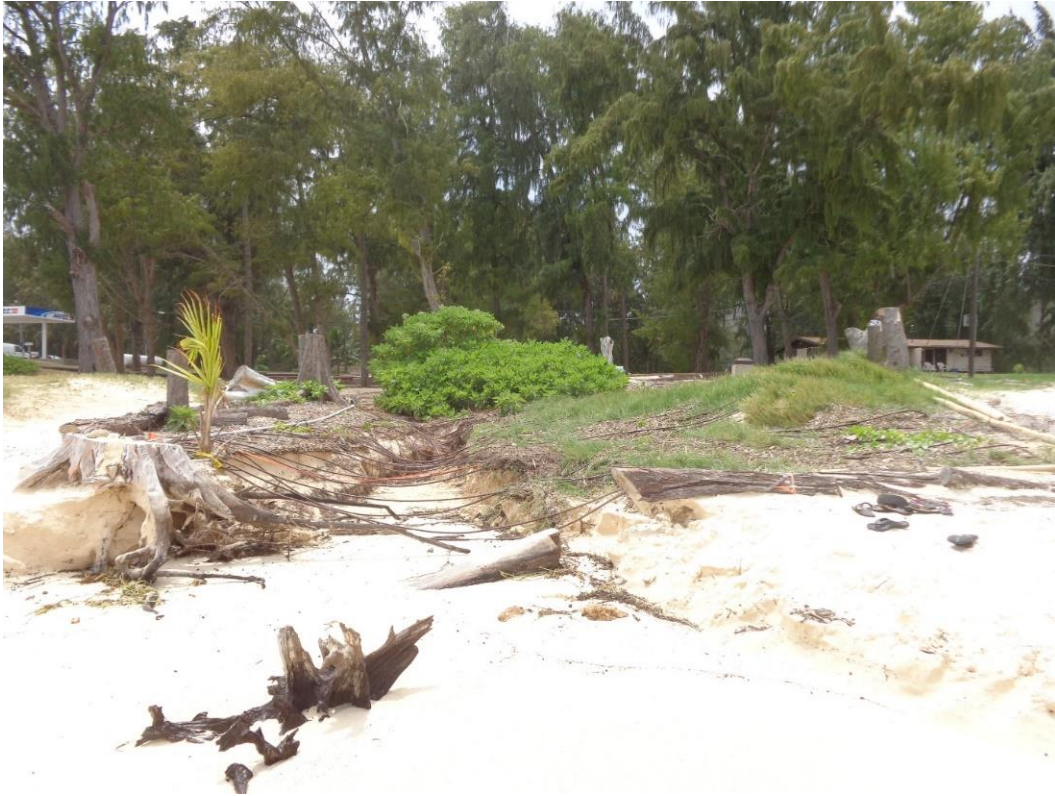
Figure 68. Plot after storm, 07/21/2014

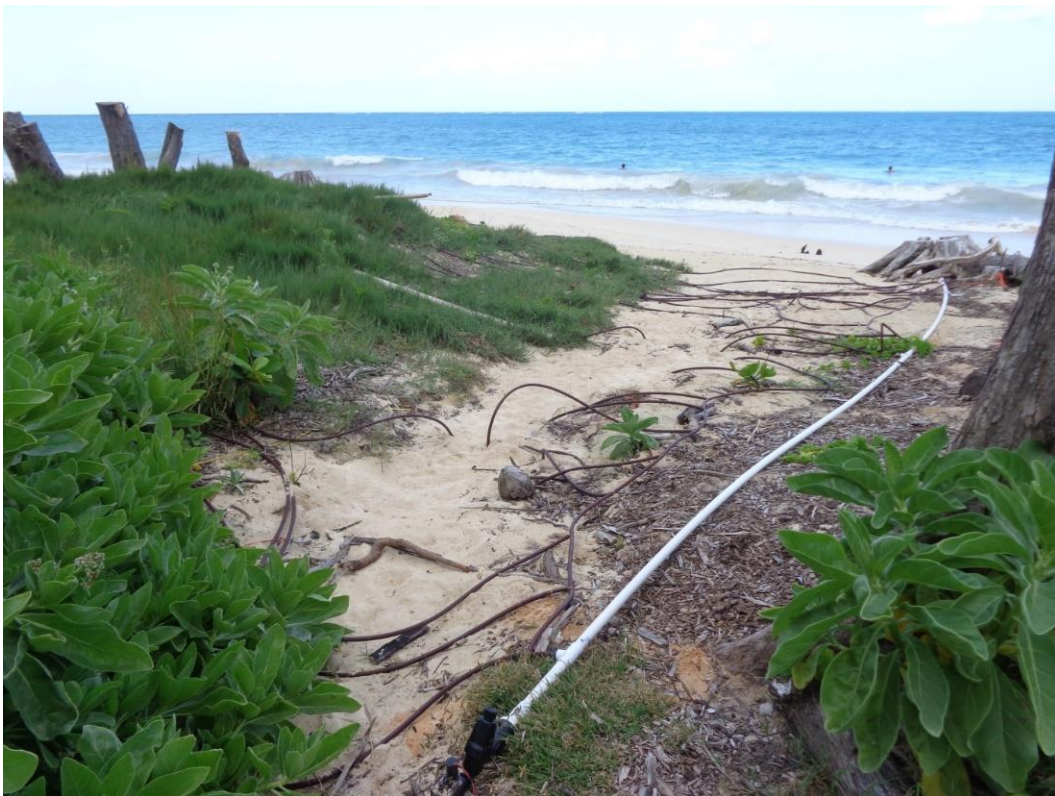
Figure 69. Sand recovered to plot with wave action and buried irrigation, 08/27/2014

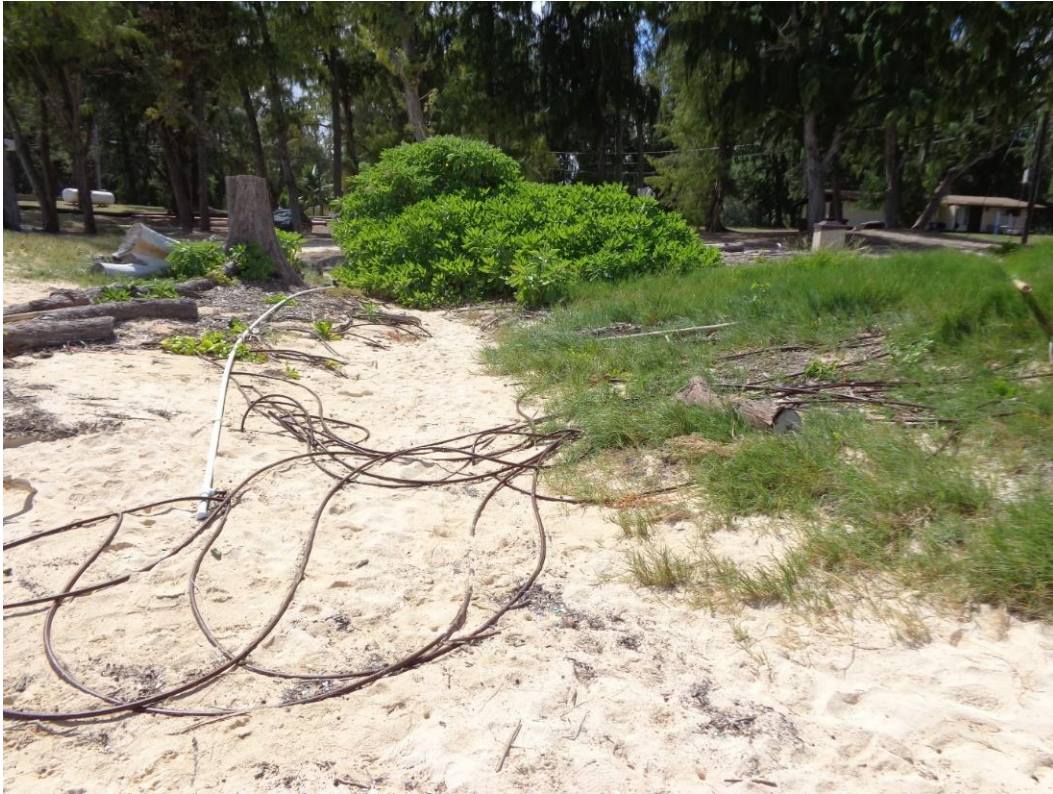
Figure 70. Sand recovered to plot with wave action and buried irrigation, 08/27/2014

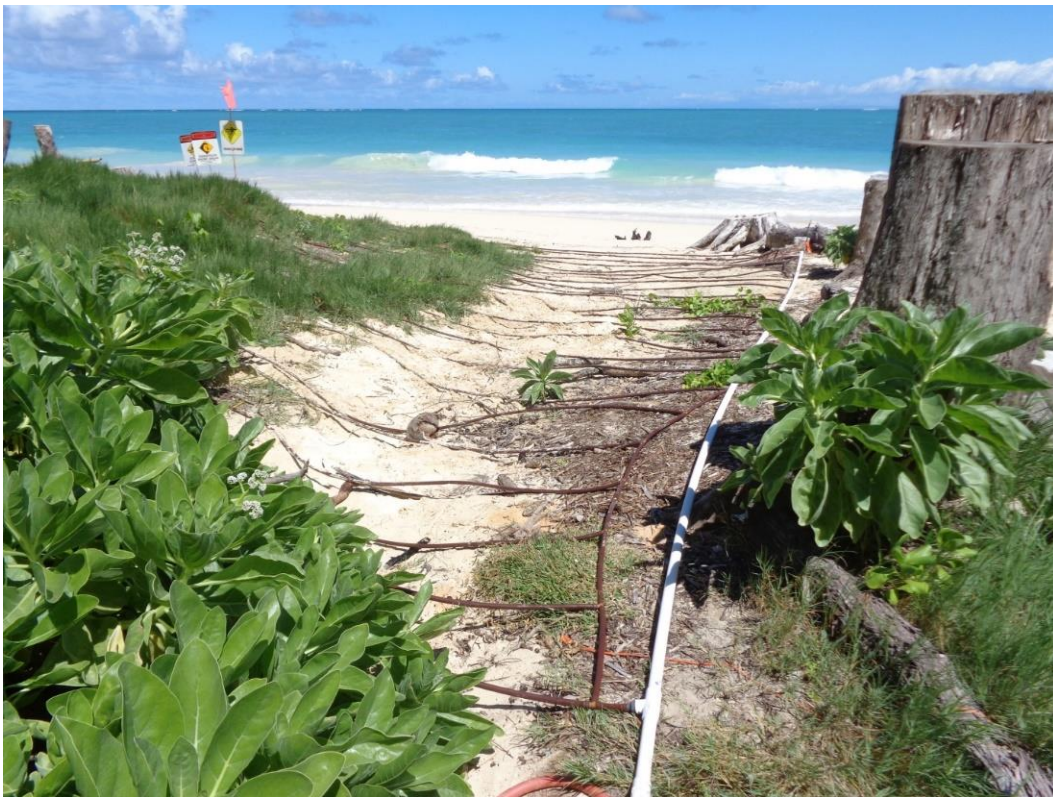
Figure 71. Sand fully recovered to plot, irrigation unburied, 09/03/2014.

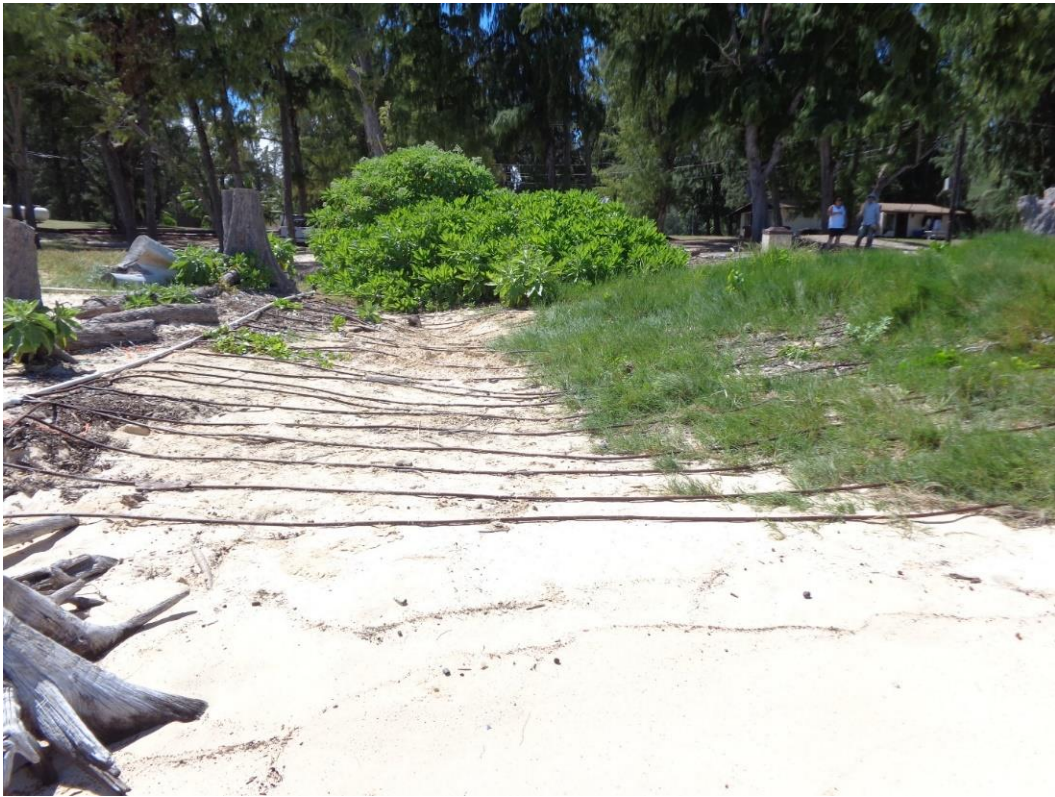
Figure 72. Sand fully recovered to plot, irrigation unburied, 09/03/2014.

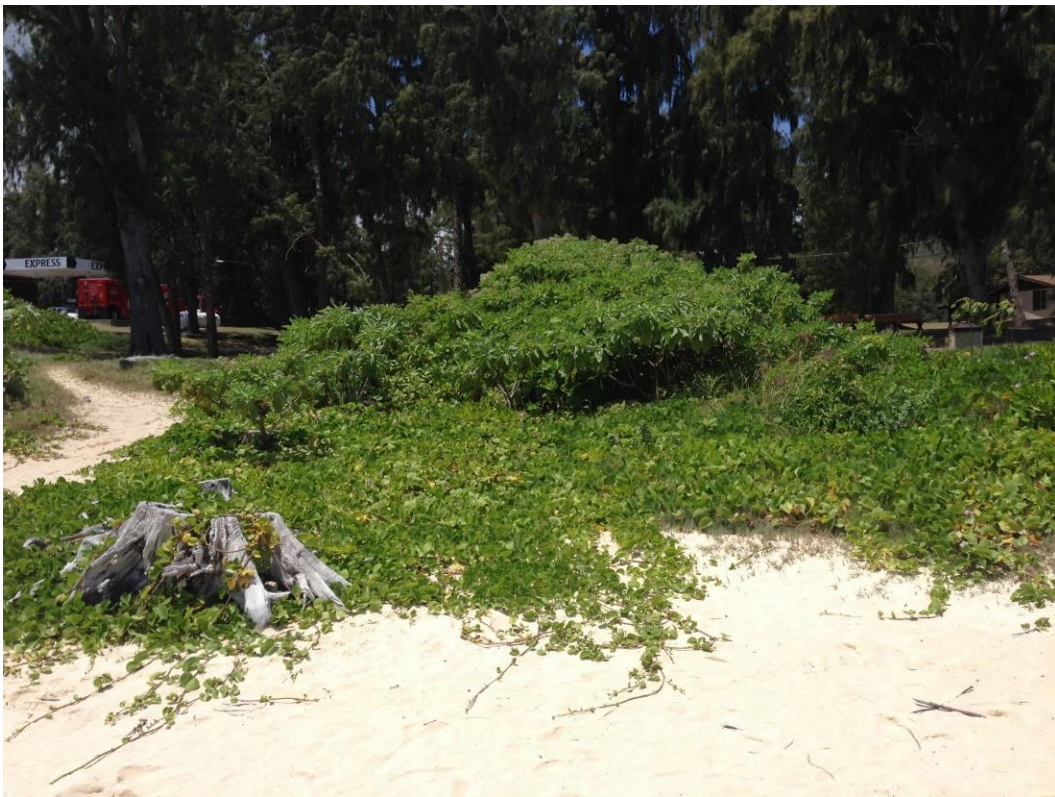
Figure 73. Vegetation recovery after storm (*Ipomoea pes-caprae* subsp. *brasiliensis*), 04/09/2015

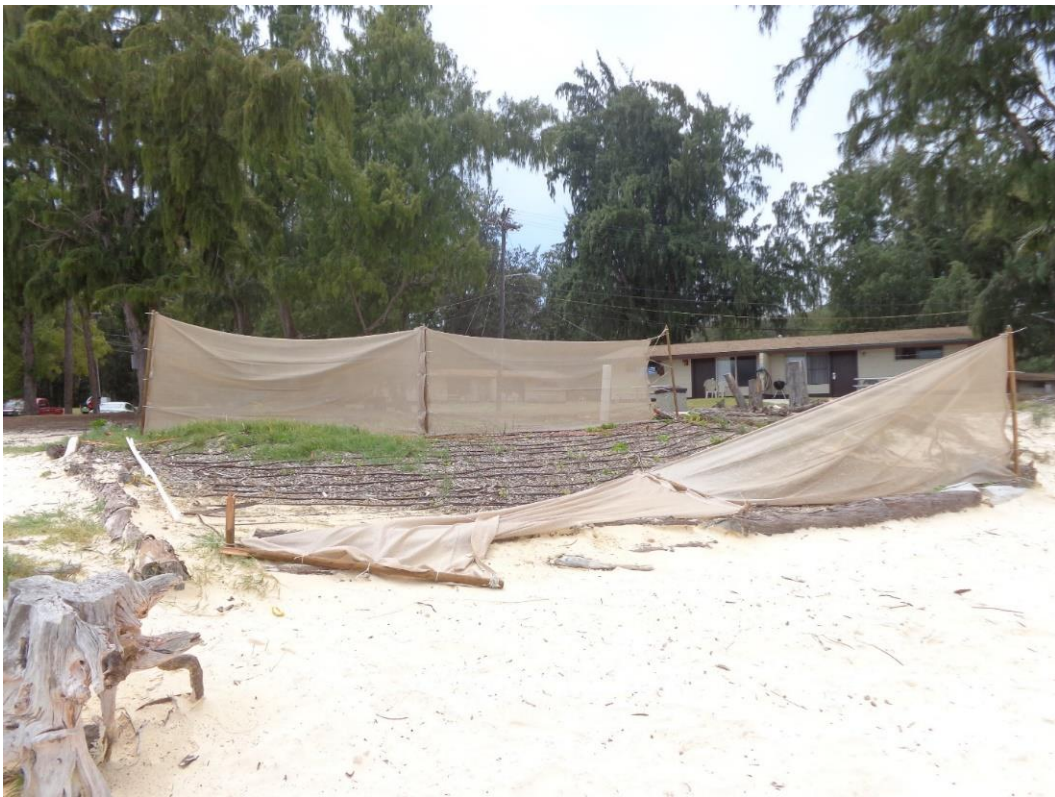
Figure 75. Wind screen damaged by storm. 07/21/2014.

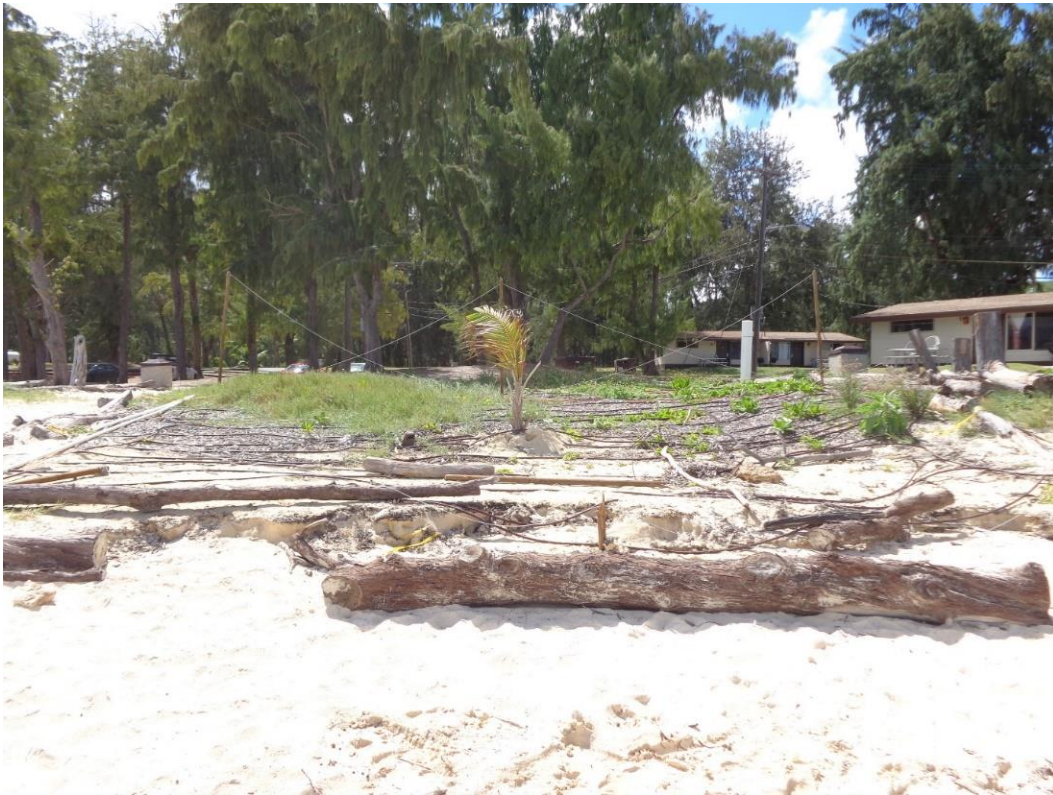
Figure 76. Wind screen was removed after second storm. 08/20/2014

The plot with screen suffered damage as well. The wind screen on the beach side of the plot did not resist the wind and the center pole broke. The screens were removed to avoid damage on the plants, and the screen in the middle of the plot was removed with a second storm warning (Figures 74-82). As the plot with no screen, the vegetation completely covered the ground, growing beyond the planting limits.

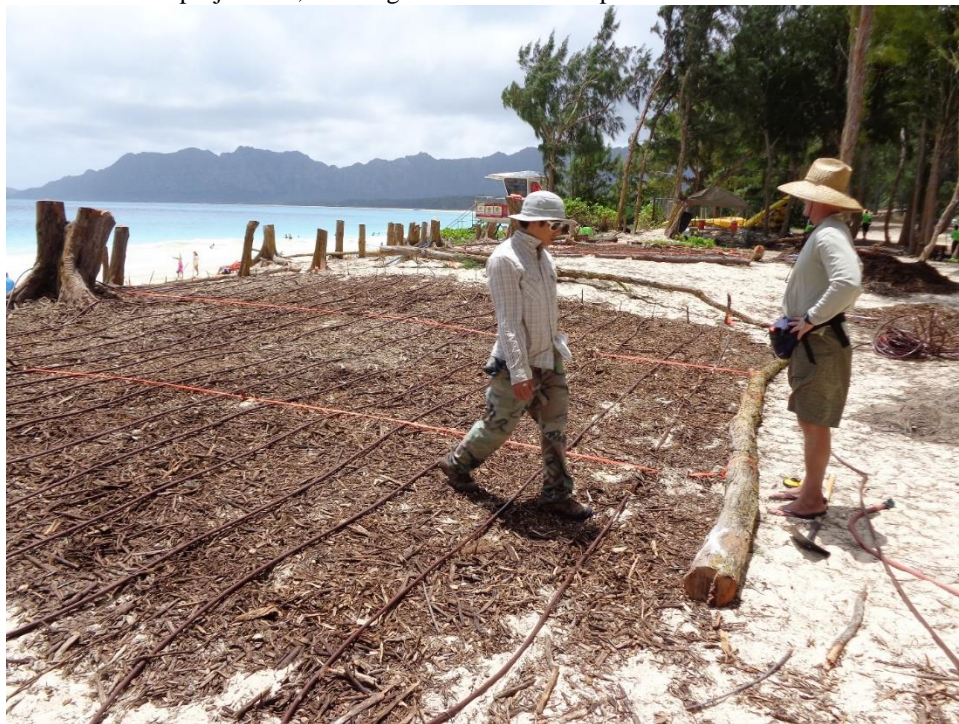
Figure 89. A project leader orienting a cadet on how to read the plant table and planting map. Note the orange tape dividing the plot in subplots for plant allocation.

After laying down logs, the mulch was spread to cover the ground about 1" thick, so that sand could not be seen though. After mulching, the irrigation lines were laid down and cut in place, and arranged parallel to each other, based on the irrigation design (Figure 88). A grid was marked to form the sub-plots in the plot, following the planting diagram (3 columns, 5 rows), using orange tape mark the lines dividing the sub-plots (Figure 89).

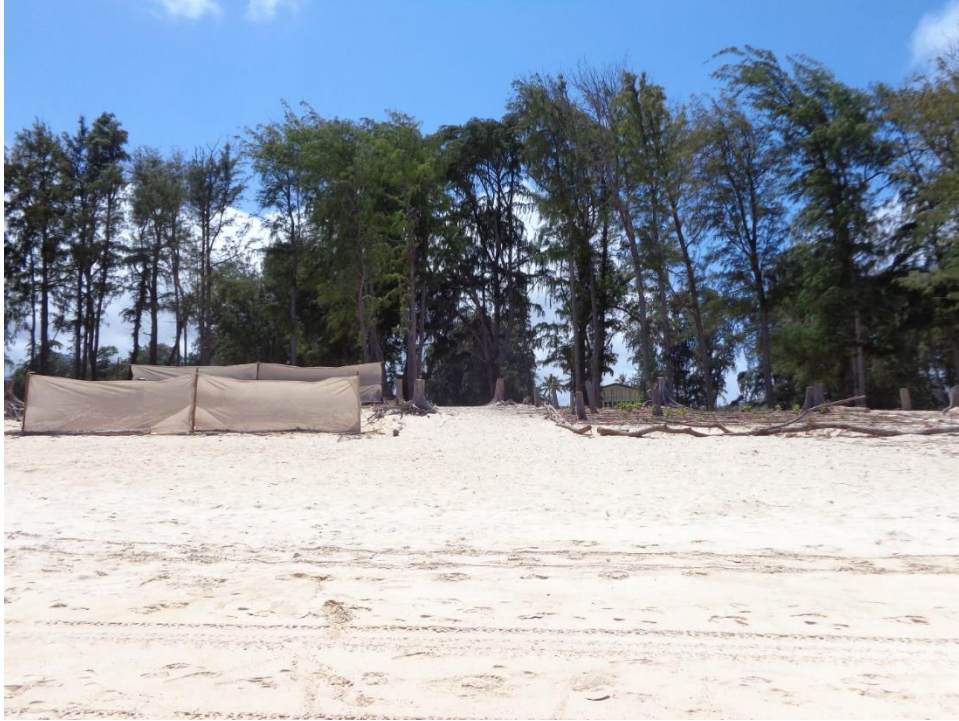
Figure 93. Plot with screen on the left (south side); plot without screen on the right.

The plot with screen had a clearly advantage in the first months after installation, covering the soil faster than the plot with no screen (Figures 97 to 112). However, the plot without screen eventually catch up and started to look similar about 6 to 10 months after planting (Figures 113-116). Finally, the plot without screen looked better than the plot with screen one year after planting (Figures 117-118). These observations will be discussed in the results, conclusions and recommendations sections.

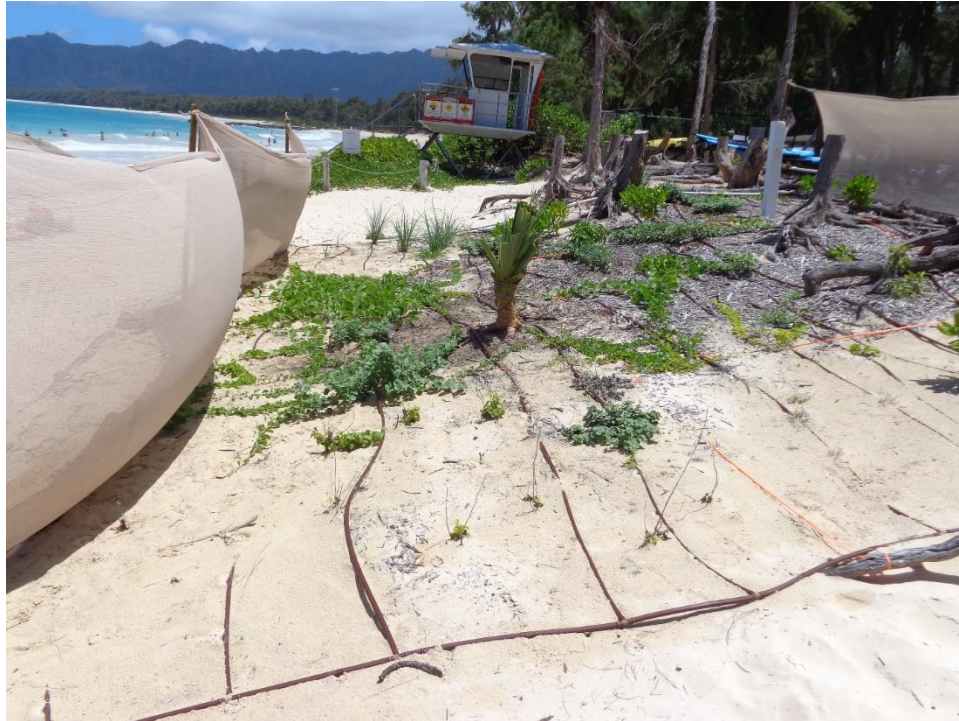
Figure 100. Plot with screen, foredune, view from north 2.5 months after planting (07/03/2014).

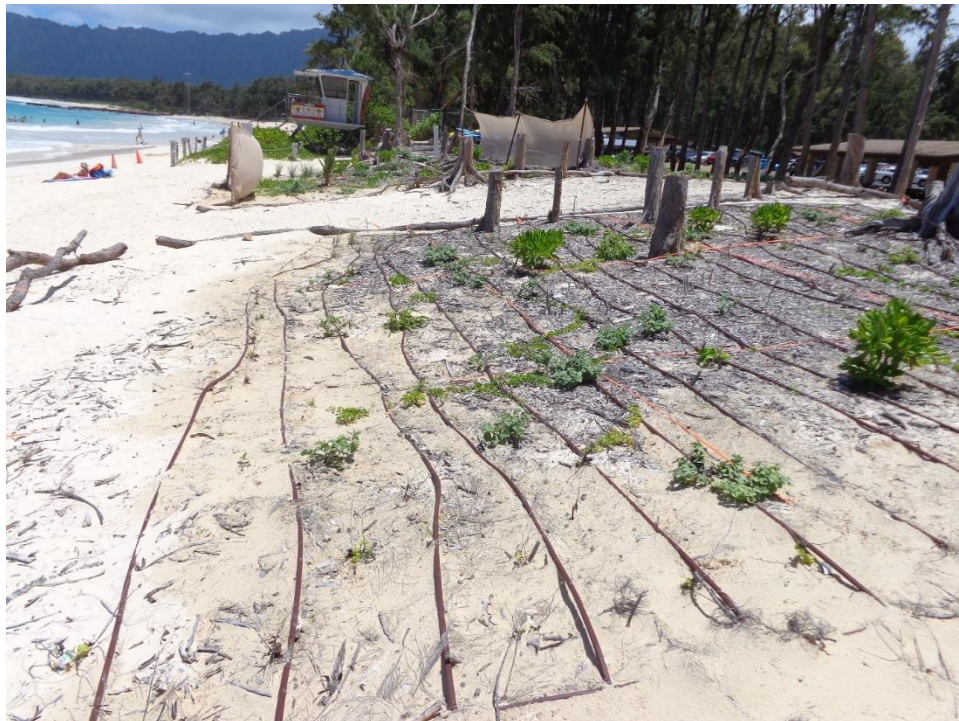
Figure 101. Plot without screen, foredune, view from north 2.5 months after planting (07/03/2014). Note how the vegetation in the plot with screen cover the plot a lot better.
